Report No. CG-D-08-00

EVALUATION OF WINDOW FAILURE MODES

**FINAL REPORT
DECEMBER 1999**

**U.S. Department of Transportation
United States Coast Guard
Marine Safety and Environmental Protection (G-M)
Washington, DC 20593-0001**

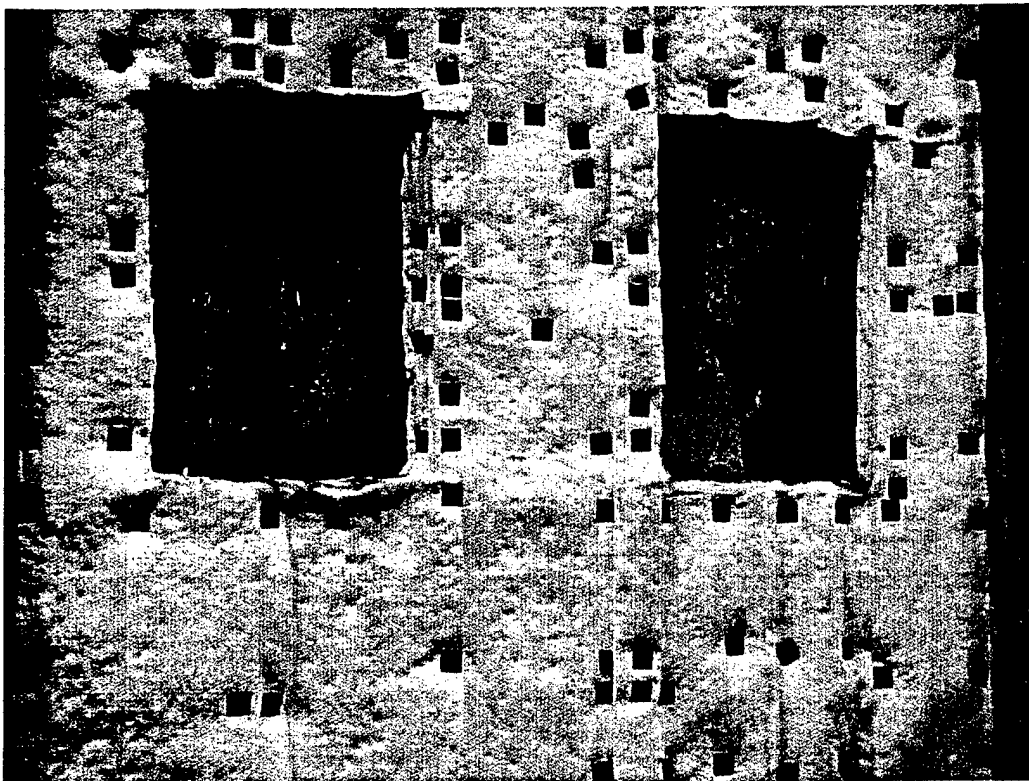
Figure 13. Photograph of exposed face - post-test.

During the test, the exposed layer of glass did fracture and fall from both of the assemblies. The gel did react to the heat, and it formed a char layer. The glass on the unexposed face of both window assemblies did not fracture or fall away.
